LIQUID METAL STRESS CRACKING OF COPPER NICKEL

T. J. Ramos
A. C. Lingenfelter

Lawrence
Livermore
National
Laboratory

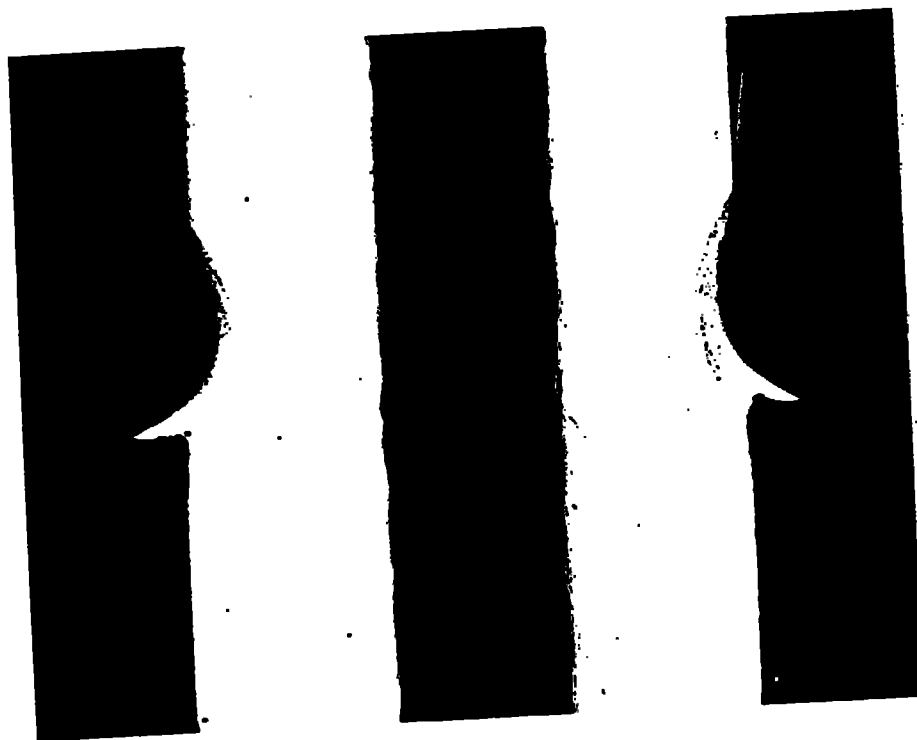
FIGURE 2

Magnification 50X

Copper-nickel tube laser tack welded onto plated copper substrate. The ammonium persulphate - HCl etchant used for the copper-nickel attacks the copper leaving it dark. Etchant: Ammonium persulphate - HCl

In the initial attempts to braze this joint, the silver plate was removed for a short distance around the tube exposing the copper. Figure 2 shows a photomicrograph of the copper-nickel tube tack welded to the copper. Note, without braze alloy present, there is no cracking apparent.

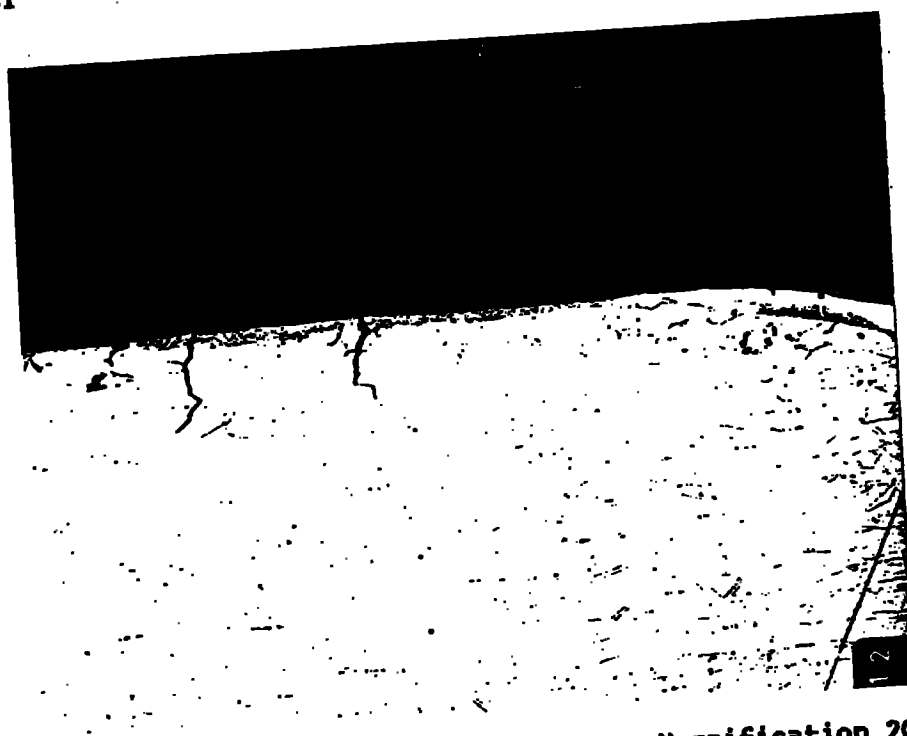
FIGURE 3

Magnification 200X

Liquid metal stress cracking of copper-nickel by AWS BAg-8 braze alloy. There is a very thin film of braze alloy on the surface. The main part of the braze is to the right on the photomicrograph. Etchant: Ammonium persulphate - HCl.

Two problems were encountered with our first effort. First, intergranular liquid metal stress cracking and liquid metal penetration of the grain boundaries such as can be seen in Figures 3 and 4 was noted in the metallographic examination. Second, the braze alloy pulled loose from the copper base material in a fashion such as is seen in Figure 6. The example shown in Figure 6 has been pressure tested to failure. The failure occurred

A microhardness survey of the recrystallized copper-nickel heat affected zone shows hardness values of R_B 77-79.5; the as-cold-worked area, R_B 88-91.5. Both structures can be seen in Figures 3 and 6.

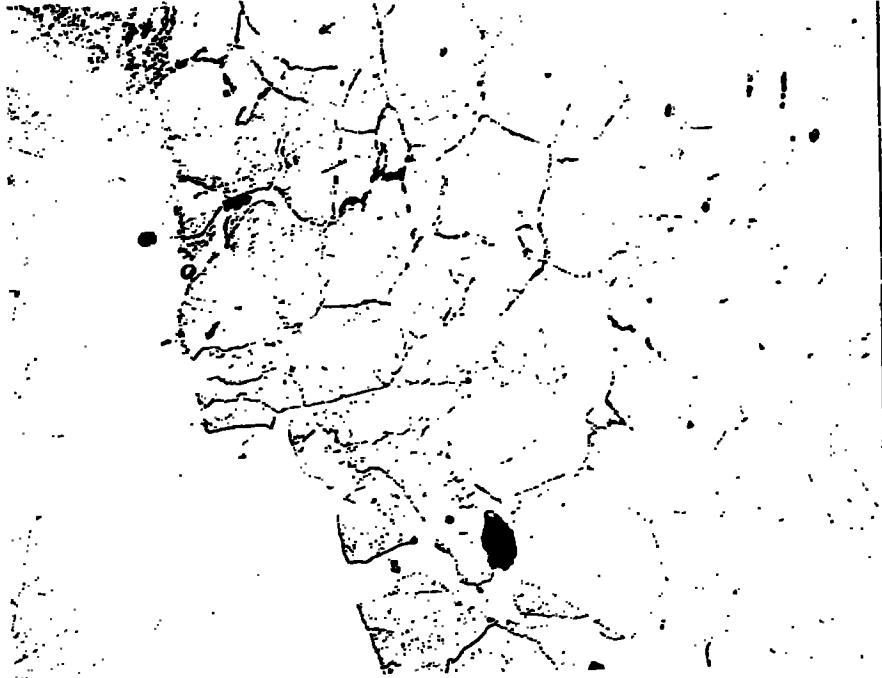
FIGURE 4

Magnification 500X

Liquid metal penetration of the grain boundaries by the AWS BAg-8 braze alloy. Etchant: Ammonium persulphate - HCl.

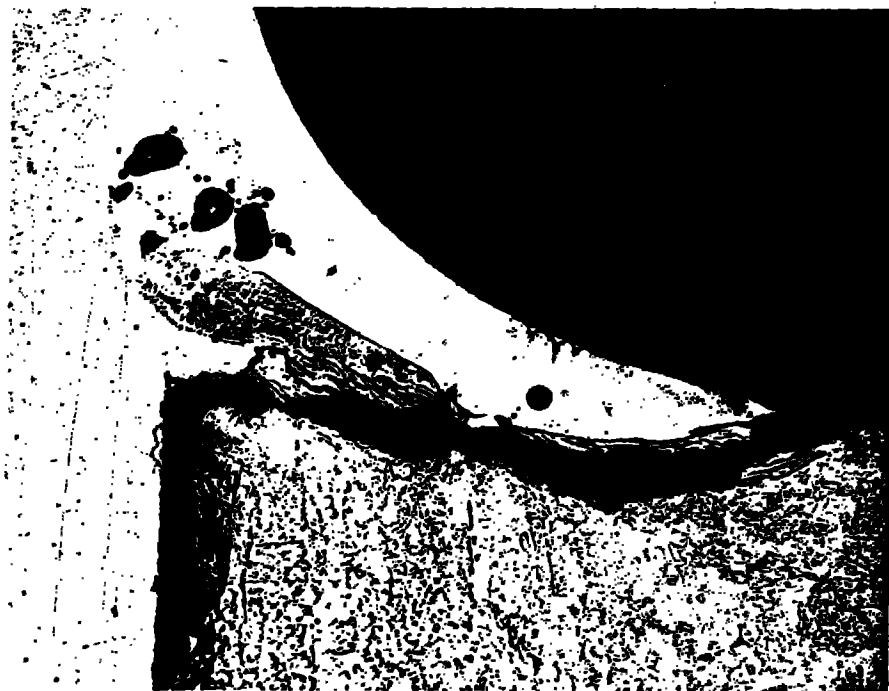
FIGURE 6

Magnification 200X

AWS BAU-4 braze on a plated copper substrate. The braze has been tested to failure. The failure occurred in the copper plated substrate. Note: no liquid metal stress cracking is seen in the copper-nickel base metal. Etchant: Ammonium hydroxide.

somewhat below the desired strength. Macroexamination of several braze joints showed the braze alloy was also pulling loose from the copper substrate in the as-brazed condition. As can be seen, the failure is occurring in the copper.
